MITIGATION OF CORROSION IN ACID PLANTS – THE IJC WAY

V. Senu Chettiar, Rm.Avadiappan, S.Subbiah,
Indo Jordan Chemicals Company, Eshidia, Jordan

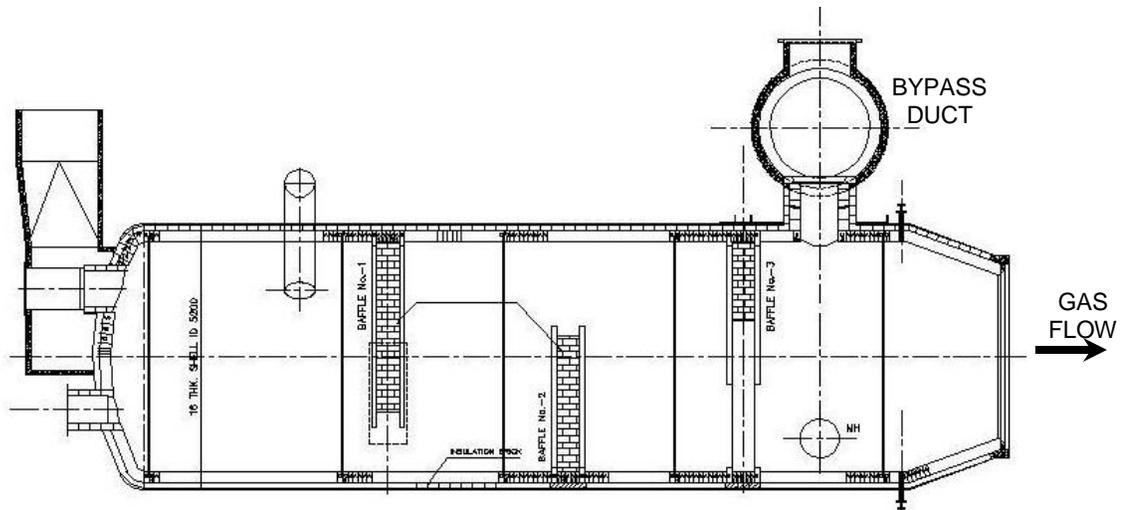
Fig 1 SULPHUR FURNACE – GENERAL ARRANGEMENT

The Furnace in IJC's Sulphuric acid plant is a Carbon steel vessel lined with 2 layers of refractory bricks, 114 mm thk insulating brick layer and 220mm thk High Alumina refractory bricklayer. The furnace is provided with 3 nos of baffles, built with refractory bricks (Fig 1).

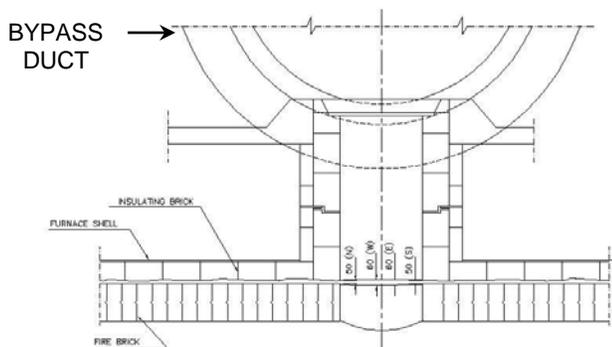
Fig 2 Sulphur Furnace – Gap in Bricklining

After 5-6 years in service, gap was observed between insulating & refractory bricklayers at the bypass valve nozzle area. The opening width of the gap kept increasing every year and in year 2006 the maximum gap was around 60mm (Fig 2).

The impact of this gap was analysed in detail to finalise the need & mode of repair. It was found that this gap will facilitate free passage of gas between the bricklayers and also between the shell and the insulating bricklayer.

Since the furnace is not insulated, the gas reaching the shell will condense into acidic sludge, resulting in possible corrosion of shell. Sagging of bricklining, observed around the bypass valve nozzle, also confirmed this possibility.

Thickness reduction was observed to the tune of around 30-40% of the original thickness for 1/6th of the circumference at top. In the lower areas, thickness values were satisfactory.

1. To repair / strengthen the already corroded area of the shell - Carbon steel patch plates were welded over the corroded areas of the shell, identified by ultrasonic thickness scanning.

2. To arrest the source of gas entry - The sagged Bricklining around the bypass nozzle was replaced with new bricks for an area of around 2.2m x 4.5m.

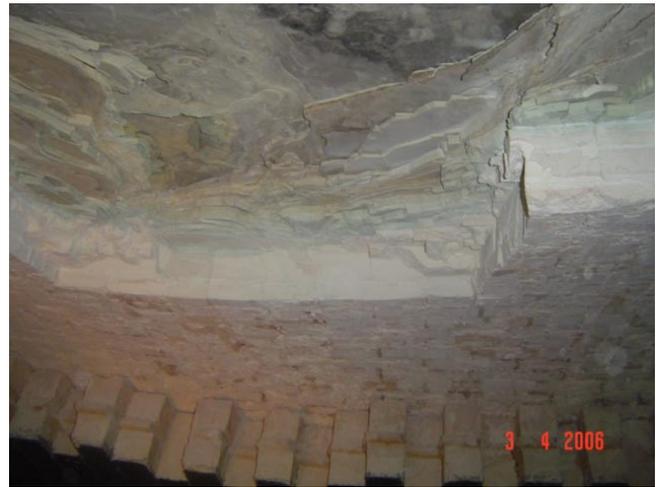
Fig 3 Sulphur Furnace – Accumulated Sludge

After removal of bricks, sludge accumulation was observed between insulating brick layer and shell plate for a max thickness of 110mm, confirming our analysis (Fig 3)

Sludge accumulation has spread over a wider area along the length and circumference of the shell. This sludge has not been removed completely. Only the gas entry point has been repaired. Further corrosion of the shell is likely, due to the accumulated sludge. The following plan of action is planned for the future.

- Regular thickness monitoring of the shell will be done during every shutdown. Patch welding will be carried out in stages wherever thickness reduction is observed.
- Condition of Shell Bricklining will be monitored during every shutdown. If any further sagging / detachment of bricklayers is observed, then Bricklining replacement will be carried out in these areas in stages.

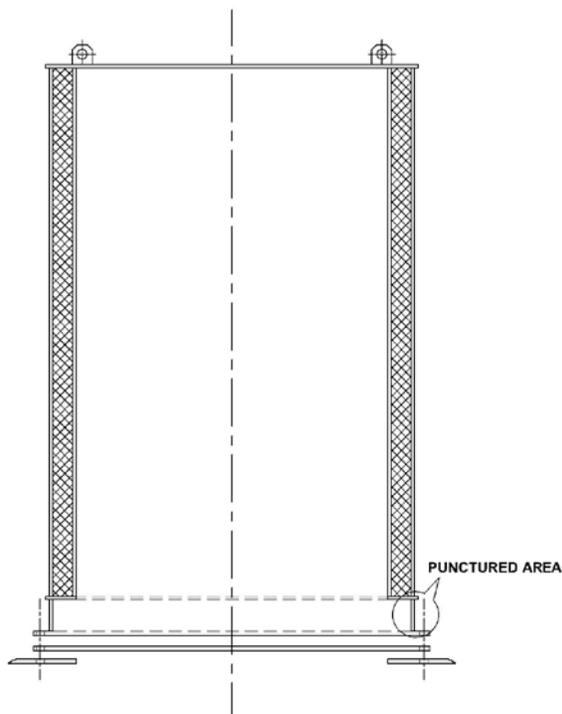
Fig 4 IPAT Candle Filter

- 4 Nos of candle filters, near to the shell leak area were found heavily corroded / punctured in the bottom collar portion, just above the seating flange (Fig 4).
- Gaps were observed between the candle filter flanges and the fixing tubesheet surface.
- At the leaky area of the shell, the shell plate was found completely corroded for a wider area.

From these observations, it was inferred that splashing of acid mist through the openings in the candle filters had caused shell corrosion / leak. Corrosion resistance of Carbon steel in the concentrated Sulphuric acid environment is mainly contributed by the formation of

adherent Iron Sulphate film in static & low velocity conditions. The high velocity splashing of acid mist would have not only damaged this protective film and also prevented further formation of the same.

All the candle filters were replaced. Adequate seating of candles over the tubesheet was ensured by light passing test.

Thickness scanning was done for the shell. Additional SS316L, outside patch welding was done over the corroded area of the shell. To avoid acid entrapment between the original shell and the outside patch plate, the shell plate edges were seal welded to the patch plate from inside.

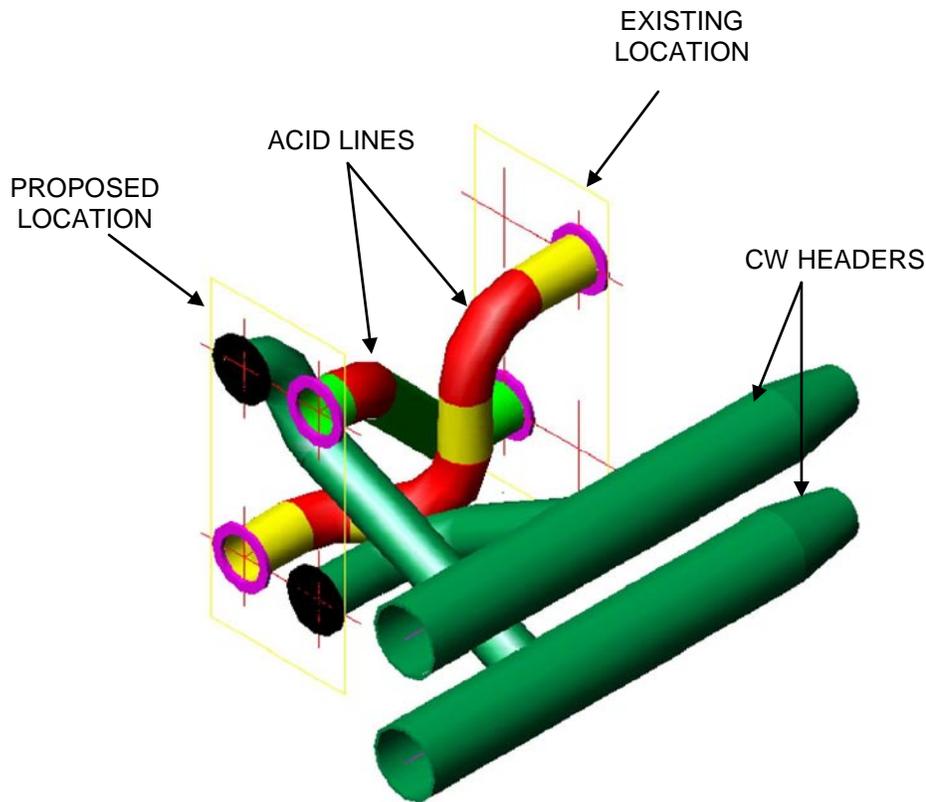
Fig 5 Scheme for interchanging Acid ports in Acid coolers

The plates normally fail (thinned down and punctured) at the acid inlet nozzle area, necessitating replacement of the entire plate pack though the other areas of the plates still have useful service life left in them.

In IJC, the average service life of the coolers is only 4~5 years. To enhance the service life of the coolers, it is proposed to interchange the acid inlet & outlet ports in the coolers which is the common industrial practice. By this way, the total amount of corrosion at acid inlet area over the entire service life is distributed over two nozzles instead of getting concentrated in one nozzle.

Hence, a novel scheme has been worked out wherein the coolers will be shifted backwards by about 2m. The gap between the existing acid line flanges and the new position of cooler nozzles

will be bridged by 2 nos of flanged spools, routed in such a way to effect the port interchange (Fig 5).

In future, acid port interchange in the coolers can simply be done by relocating the coolers and installing or removing these additional spools. Since the nozzle size in 5 out of 6 coolers is same, these spools can be maintained as common spare for all these 5 coolers. Fabrication of these spools is an one time expenditure.

This modification is planned for next ATA 2008. Thickness of the heat transfer plates at the acid inlet port in all the coolers will be checked with Micrometer. The original thickness of the plates is 0.6mm. If the measured thickness is less than 0.4mm, port interchanging will be carried out by introduction of these prefabricated flanged spools. By carrying out this modification, a permanent & simple system for interchanging of acid ports in Sulphuric acid coolers will be made available.
